Horizon 80mm and 100mm
Maintenance and Service Guide

Section Index

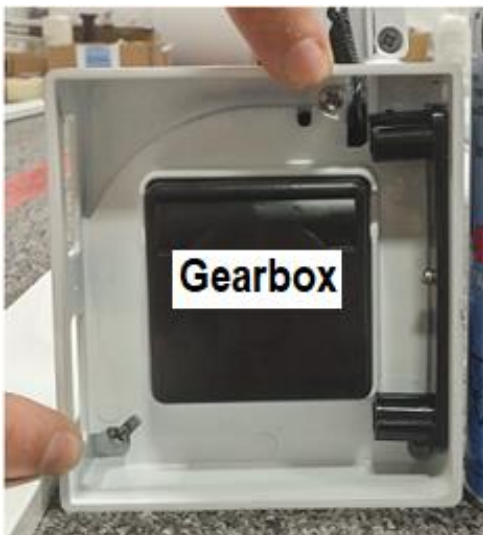
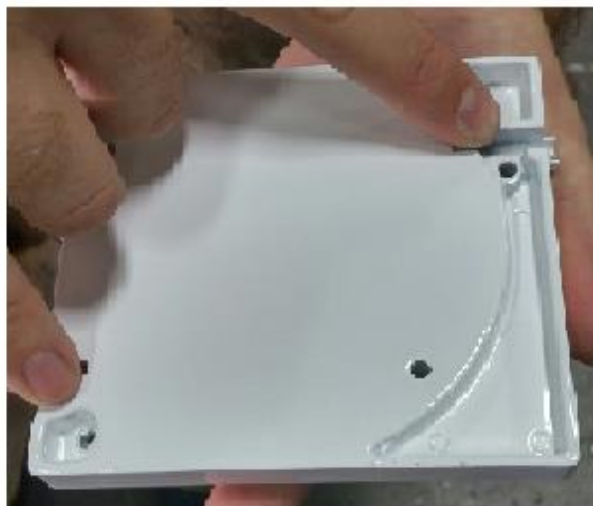
Top endcap – remove 2 screws

Bottom endcap – remove 2 screws

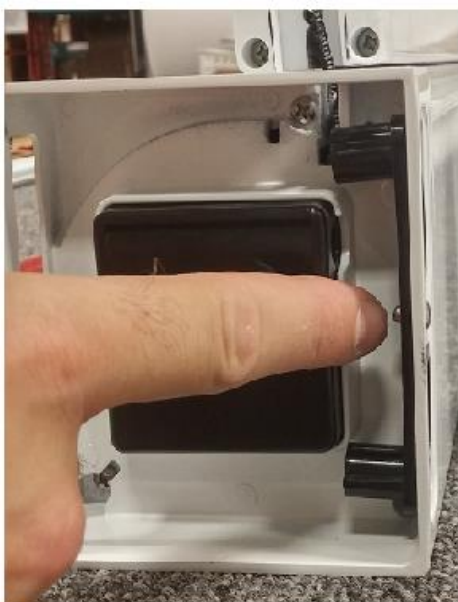
Top endcap – remove 1 rivet in backer

Top endcap – remove 2 screws

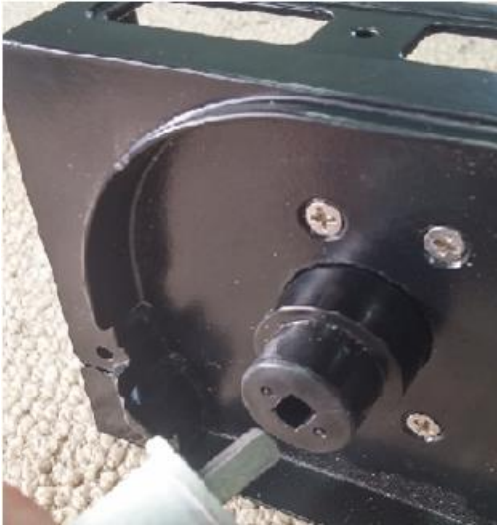
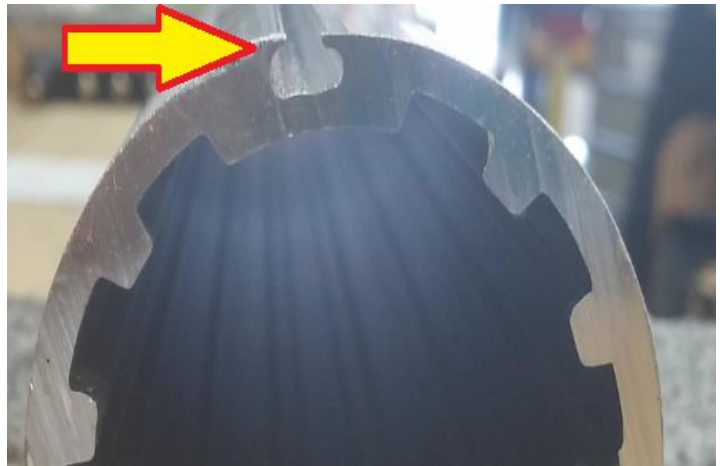
Remove: front housing, cap & spring
CAREFULLY it is under tension

**Match mesh spline to the roll tube*

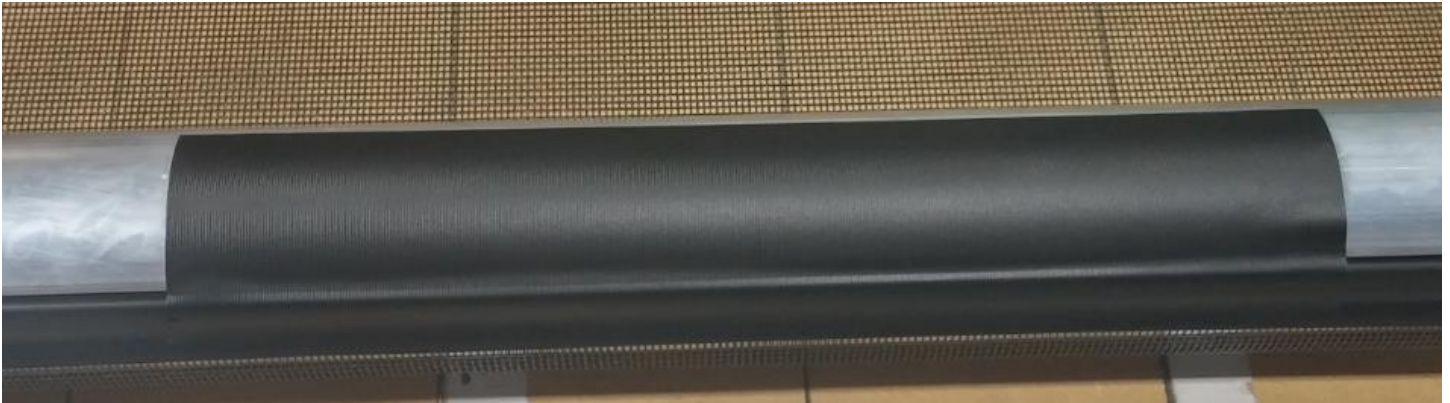
Secure the tape and roll up the mesh with the existing tape

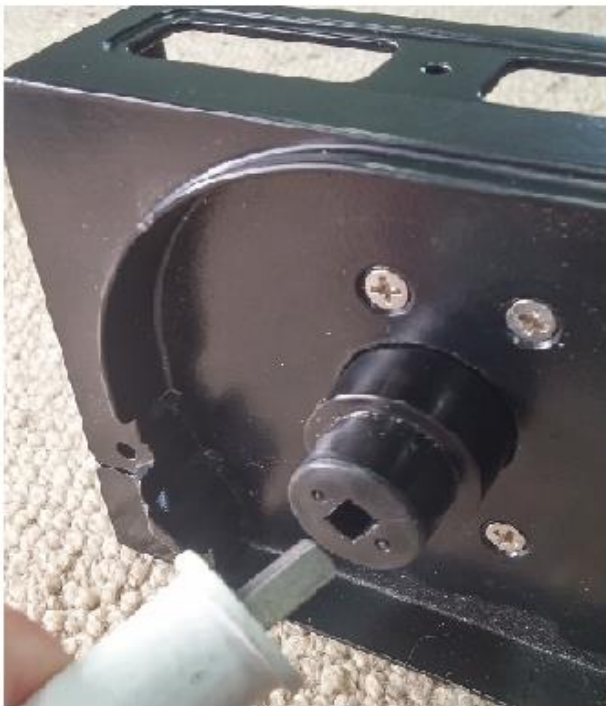
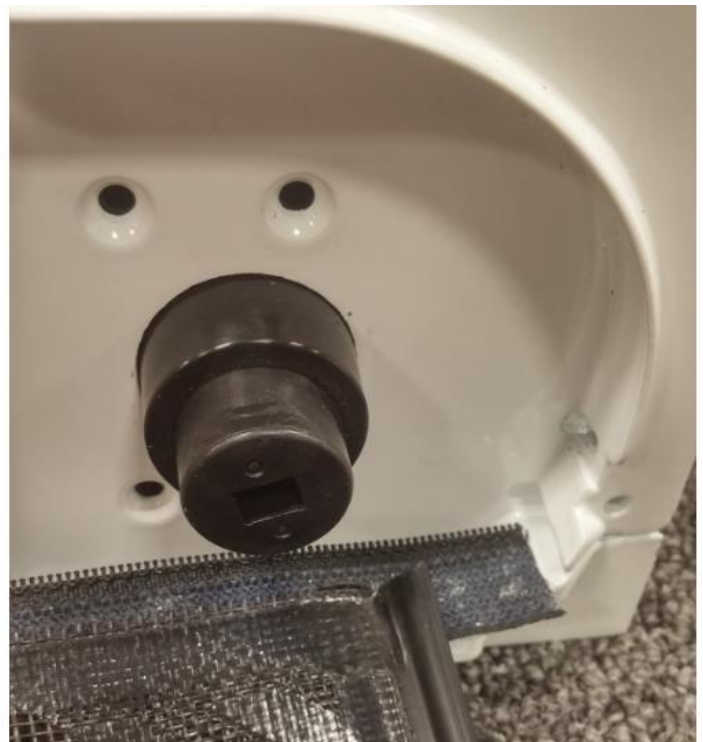
Place the spring in the upper endcap, re-attach the endcaps, and feed the mesh into the endcaps

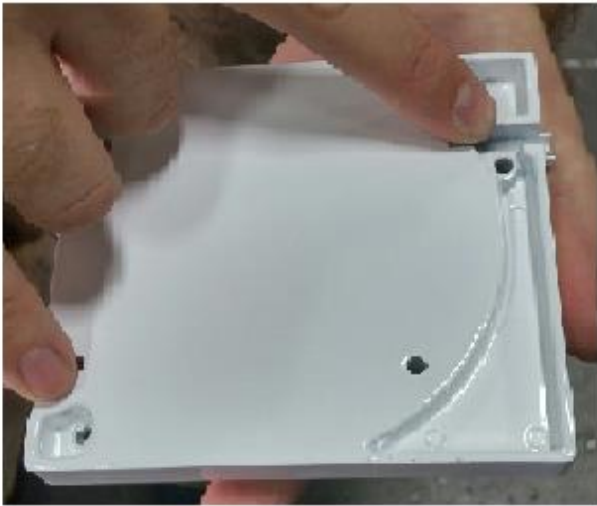
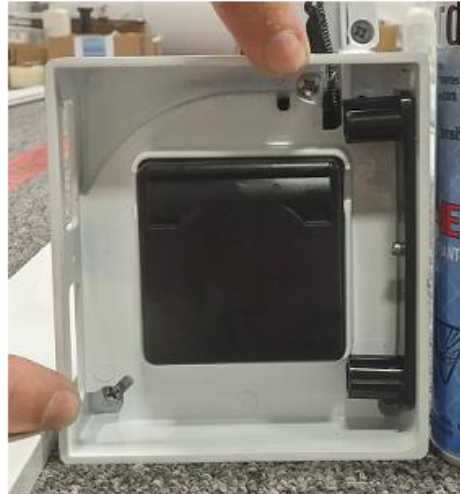
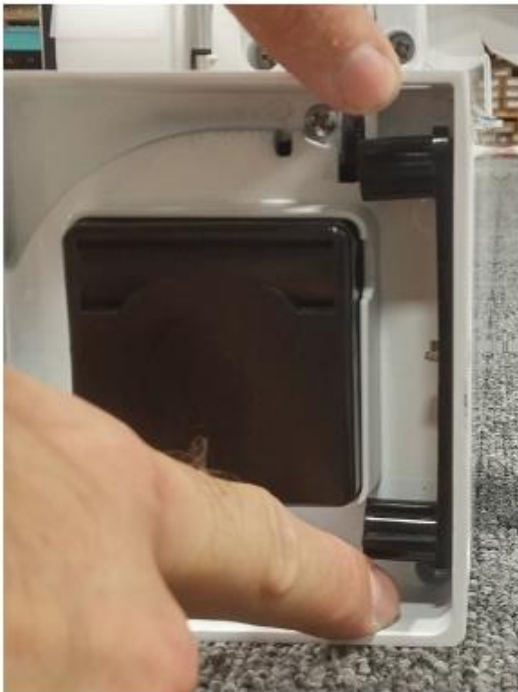
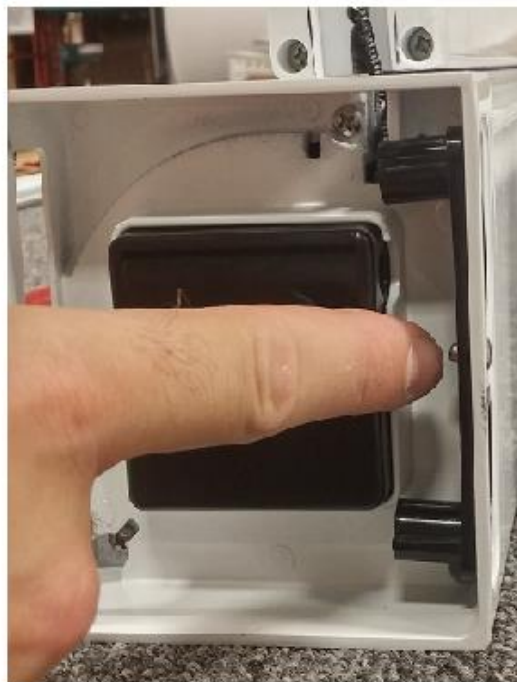
Replace the front cover by installing top and bottom screws, and the backer plate with a single screw (supplied by others)

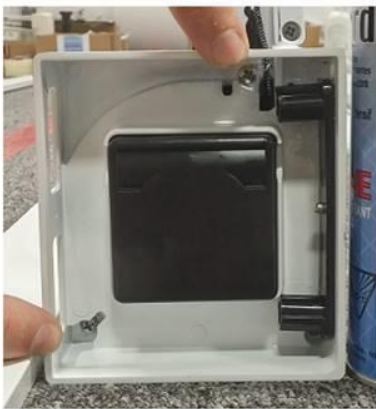
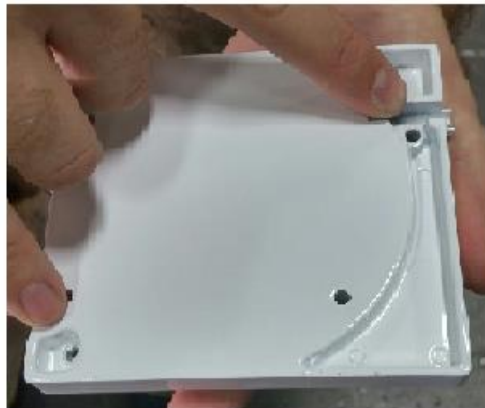
Top endcap – remove 2 screws Bottom endcap – remove 2 screws

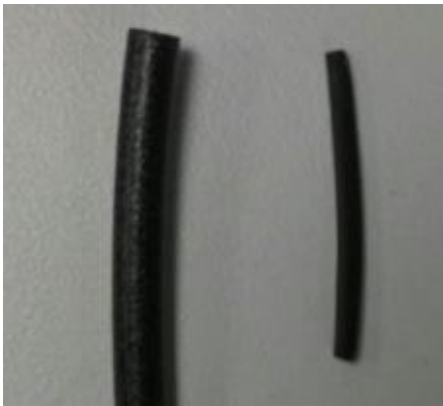
Lower Track Spline on left, cut to fit

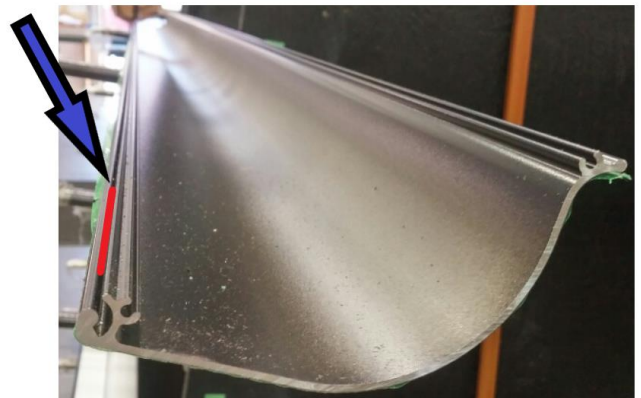
Locate small spline in the channel

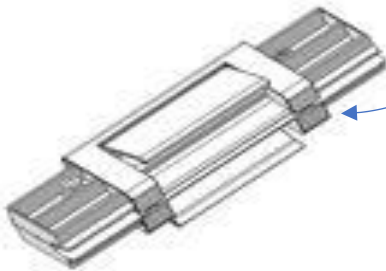
Remove the handle cover plate - insert a flat head screwdriver around the mohair to unclip

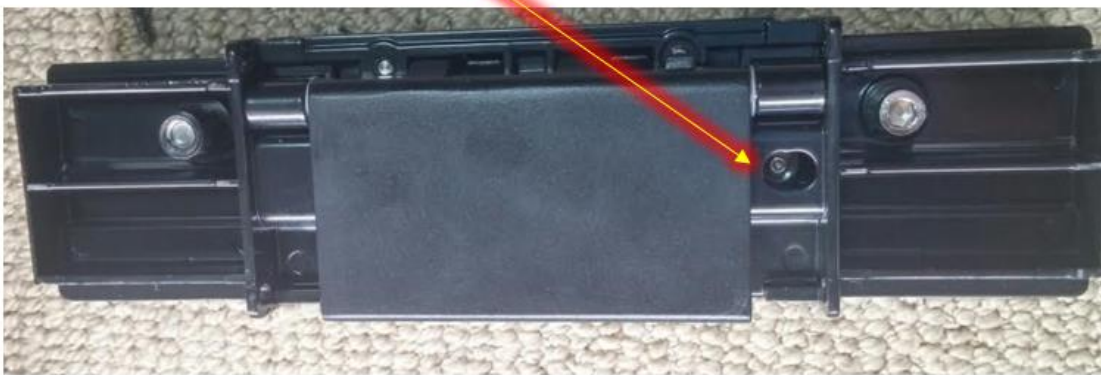
Unscrew the 2 small 2mm Allen screws (one on each side, one at the bottom and one at the top)

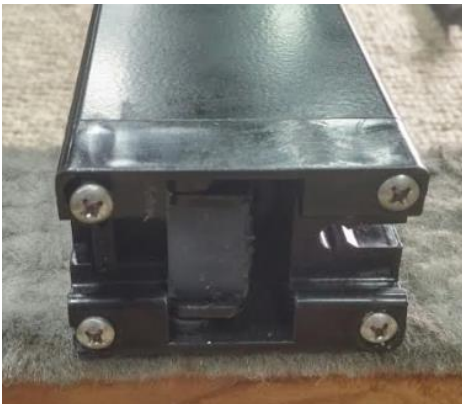
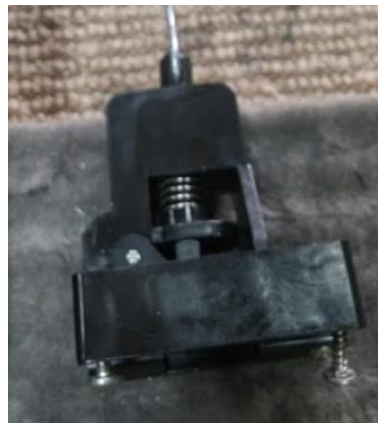
Unscrew and remove the endcaps from the pull bar – 4 screws on each end

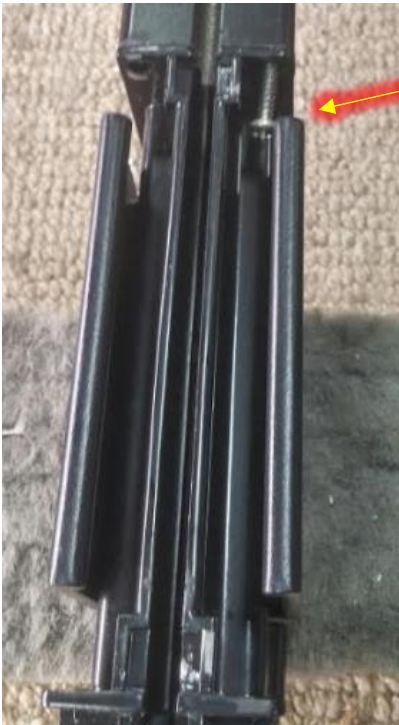
Remove the 8 screws that fasten the handle to the Pullbar, 4 on the top and 4 on the bottom and separate the handle from the Pullbar

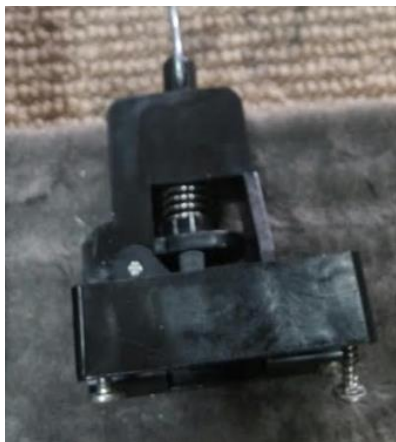
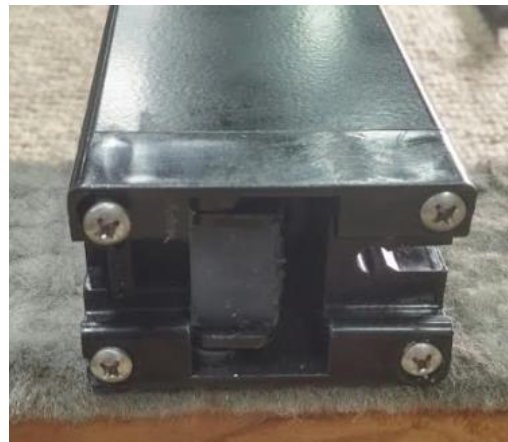
To rebuild, hook the brake rod onto the Pullbar endcap, insert the endcap into the handle and re-fasten the 4 screws on one end of the Pullbar

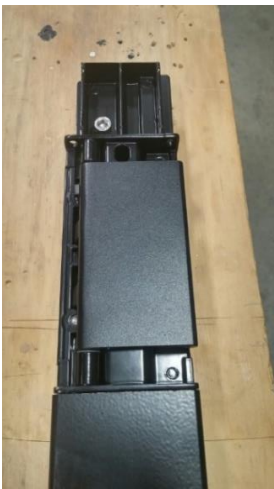
A

A) Brake rod projects out the other end of the Pullbar, feed the brake rod it the slot in the handle, make sure the brake rod is located in the slot with the screw – do not tighten the 2mm Allen screw

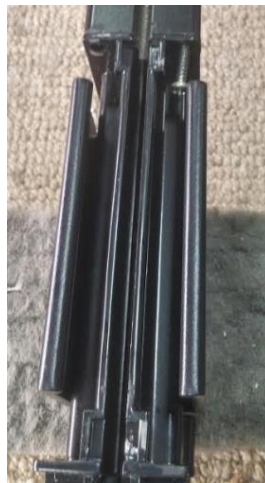
B

B) Insert the handle into the Pullbar

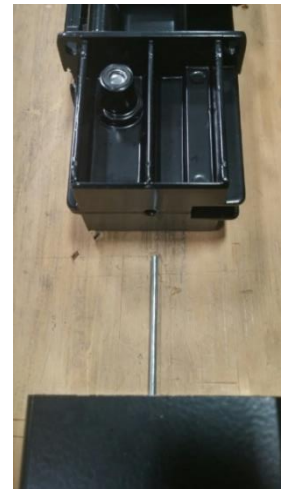
C

C) Fasten the 4 screws to connect the handle and Pullbar

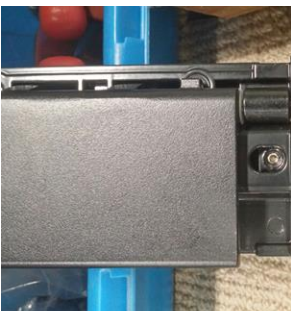
Release the handle, position the lower set screw is as low as possible in the channel before tighten the 2mm Allen screw, tighten the screw, both sides then replace the covers

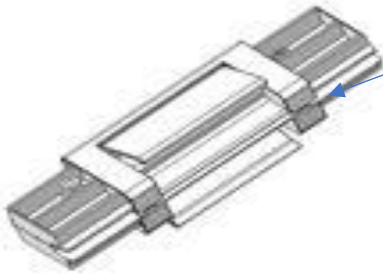
With a flat head screwdriver, gently remove the handle cover plate - insert a flat head screwdriver around the mohair to unclip

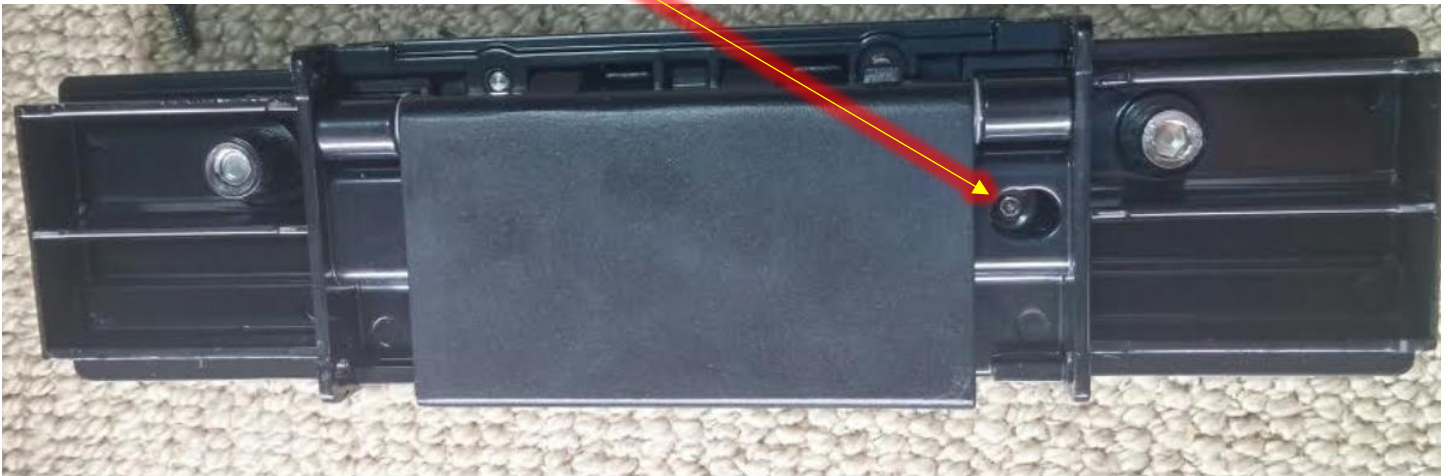
Release the 2mm Allen set screws in the handle – 1 on each side, 1 on the top side, 1 on the bottom side

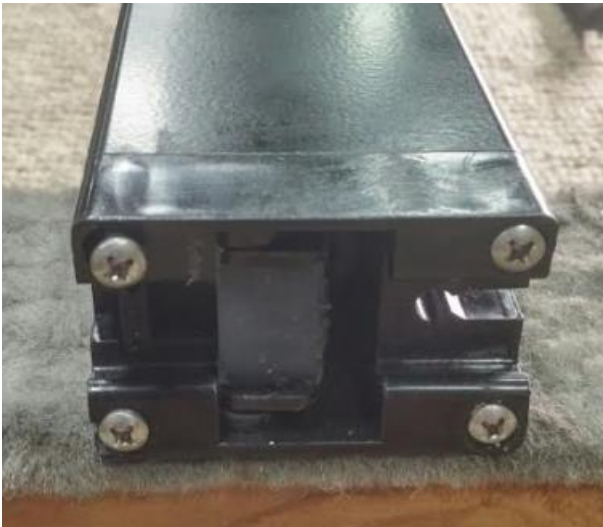
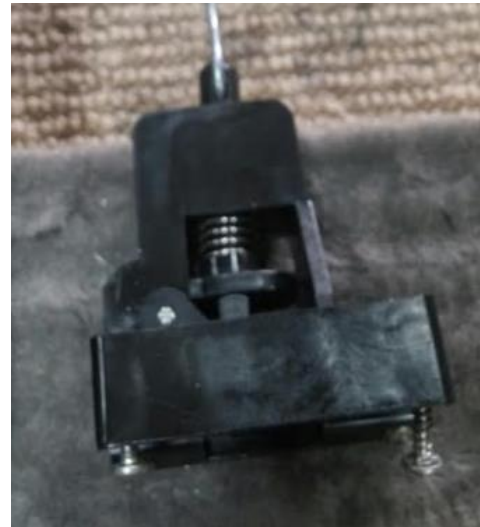
Remove the 4 screws from each Pullbar endcap, and pull out the endcap

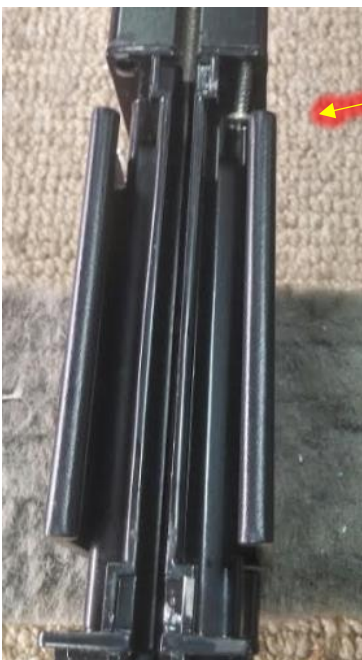
Remove the 8 screws that fasten the handle to the Pullbar, 4 on the top and 4 on the bottom and separate the handle from the Pullbar

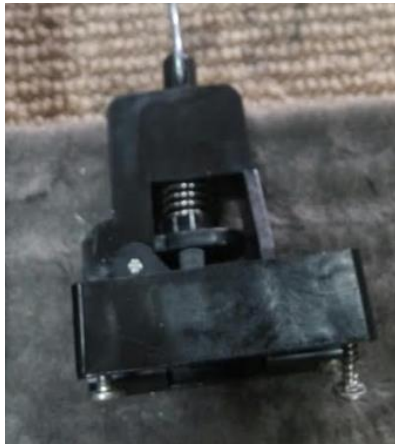
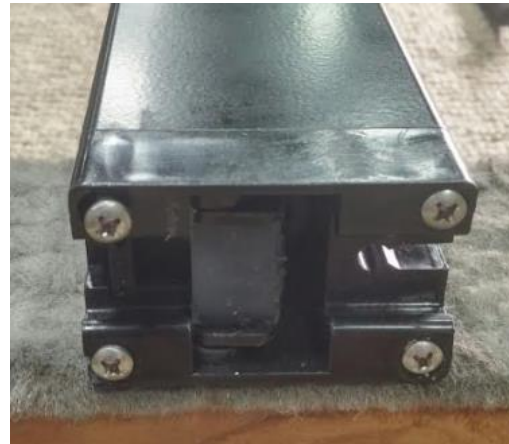
To rebuild, hook the brake rod onto the Pullbar endcap, insert the endcap into the handle and fasten the 4 screws on one end of the Pullbar

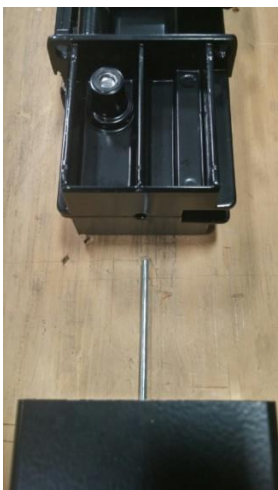
A

A) feed the brake rod it the slot in the handle – do not tighten the 2mm Allen screw

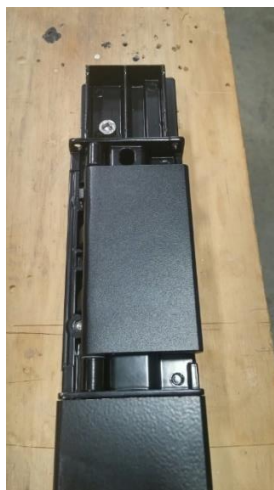
B

B) Insert the handle into the Pullbar

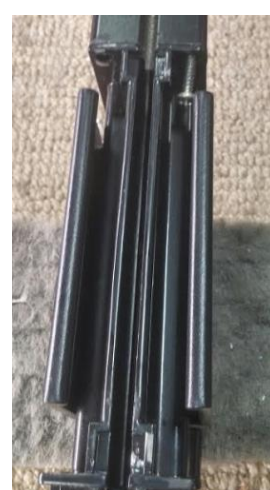
C

C) Fasten the 4 screws to connect the handle and Pullbar

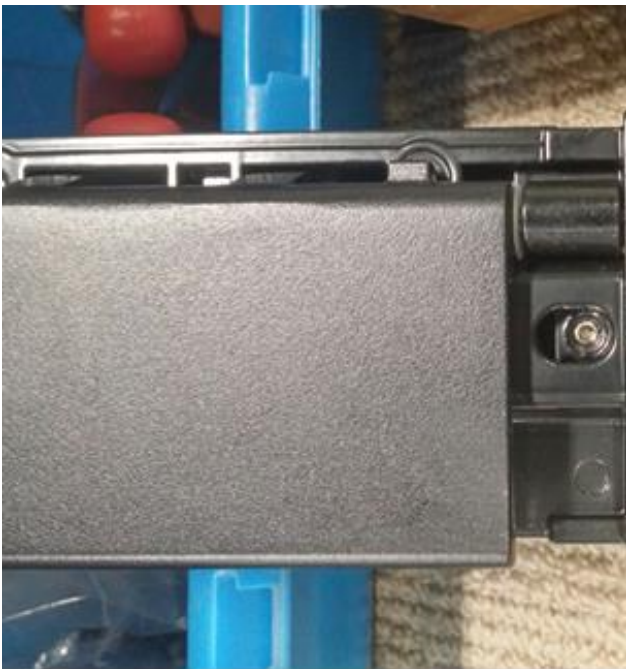
With the handle released, before tightening the 2mm Allen screws, position the lower set screw is as low as possible in the channel – then tighten the screw.
